Wailupe and Kulouou Watershed Assessment and Protocol Development

Maunalua Bay, Hawaii

Final Report by

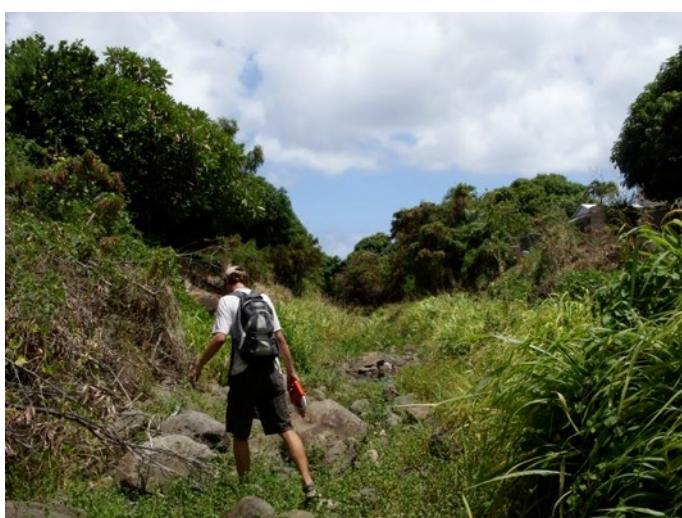
Figure 1: Wailupe stream, one of a few natural bottom streams in the Maunalua Bay area.

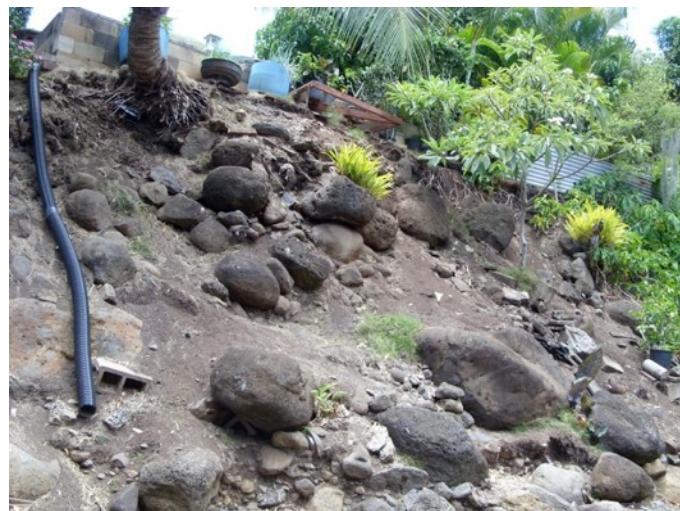
Figure 2: Corrugated pipe running from residence to channel along Wailupe stream and planting along bank, perhaps to prevent more erosion.

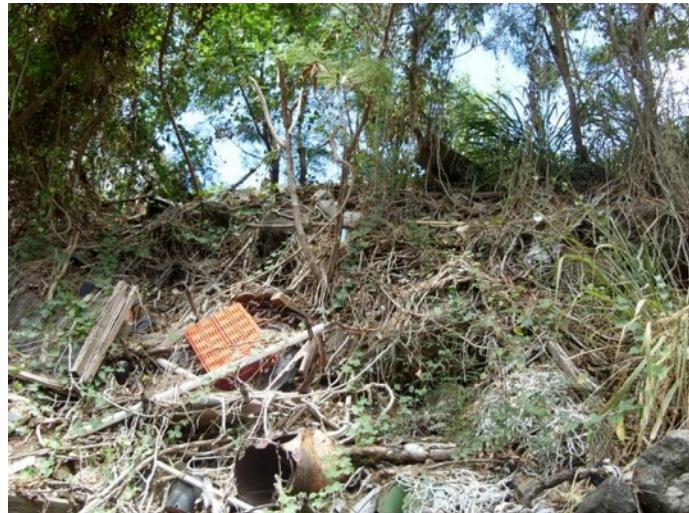
were several locations where yard waste had clearly been placed in the stream channel. In addition, one residence was using the stream channel to dump trash such as a trampoline, construction materials, pottery, and Christmas lights (Figure 3). Less than 5% of the residents were using the stream to dump construction materials. A few residents had extended their yards into the stream bank and were planting trees and other plants.

Figure 3: Trash dumping along Wailupe stream was common. In this location, decorative lights, pots, and a trampoline had been dumped into the stream channel.

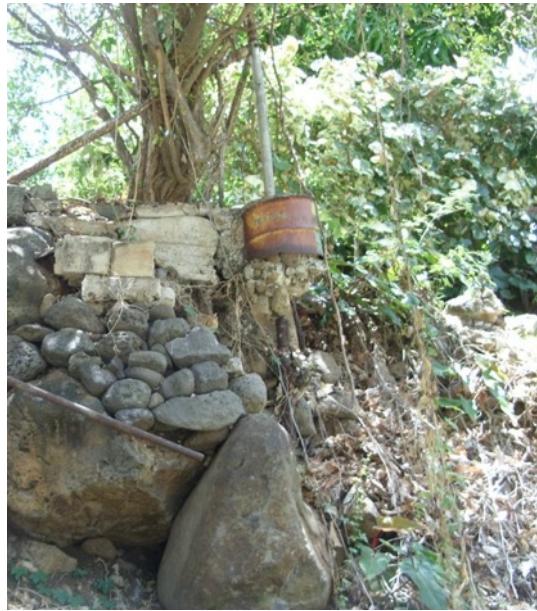
Severe erosion occurred along much of the banks of Wailupe. Specific locations of severe erosion were recorded. In some cases, bank instability appeared to be a threat to property (Figure 4). Slope failure and undercutting were both common along the stream (figures 5). In some areas vegetation covered stream banks and helped stabilize sediments; however large boulders were frequently loose. Boulders and fine sediments were also observed at the mouth of Wailupe stream. Bank stabilization is highly recommended.

Figure 4: Severe Erosion along Wailupe Stream. Erosion was a threat to property in this picture. The ban was eroded away from fencing on the property.

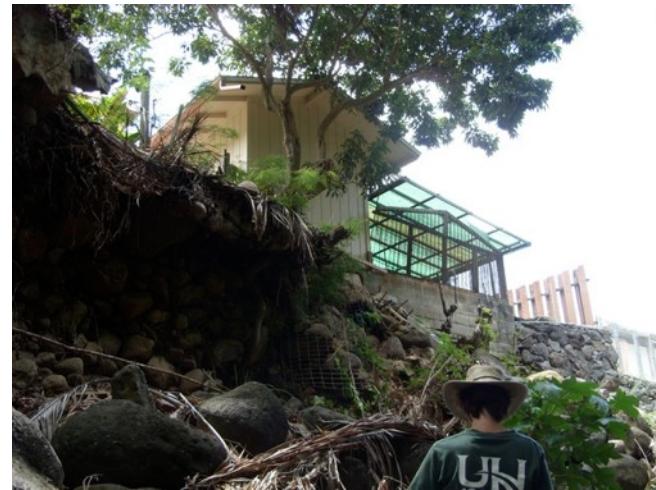
Figure 5: Bank undercutting along Wilupe stream, an example of severe erosion.

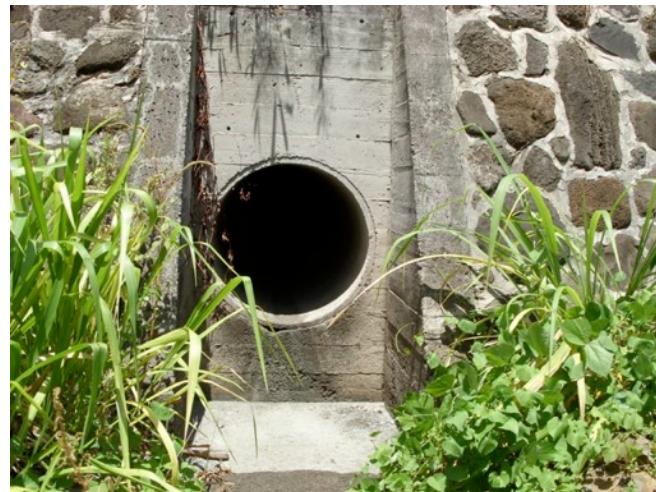
Figure 6: Typical storm water outfall observed along Wailupe stream, roughly 1 m in diameter. Outfalls were clean and usually few of plant debris.

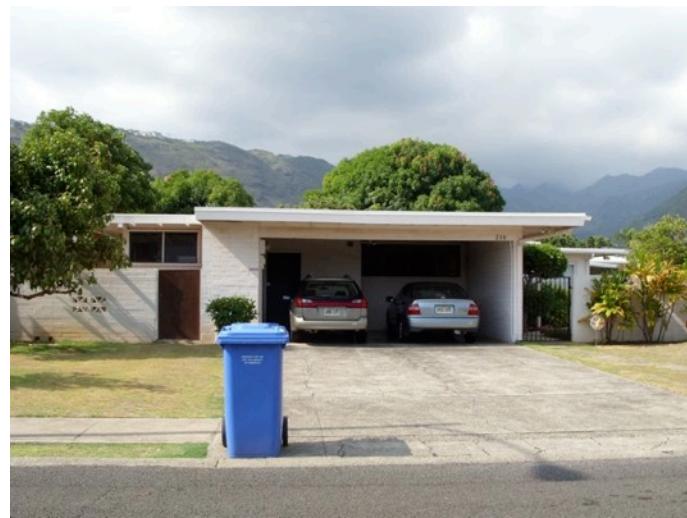
Figure 7: Average home in Wailupe watershed with carport, clean driveway and sidewalks, and manicured lawn.

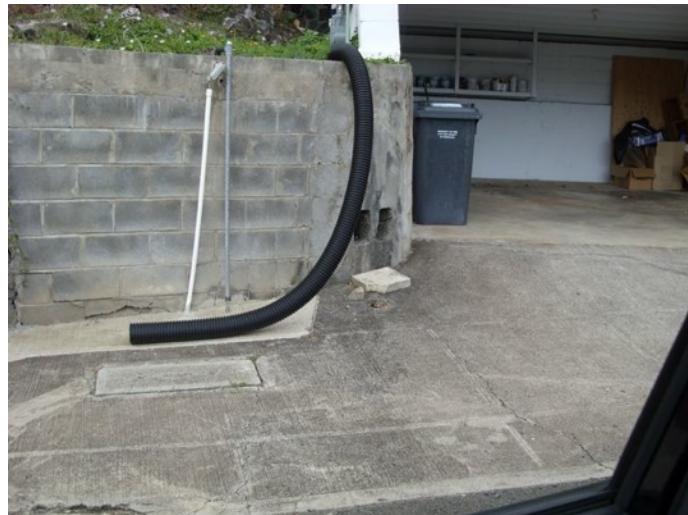
More than half of the residents in Wailupe watershed have pipes (PVC or corrugated) that lead from their houses and yards directly to sidewalks (Figure 8). Sometimes these pipes are connected to gutters or storm drains. This was the most noticeable behavior of residents in Wailupe watershed regarding storm water runoff. Pipes that are not connected to pervious surfaces do not allow rainwater to percolate down through soils, naturally filtering the water and slowing the speed at which freshwater enters Maunalua Bay.

Figure 8: Pipe running from residence directly to sidewalk, a very common practice in Wailupe neighborhoods (Aina Haina). Pipe is connected to impervious surface and decreases filtration of runoff before entering the stream channel.

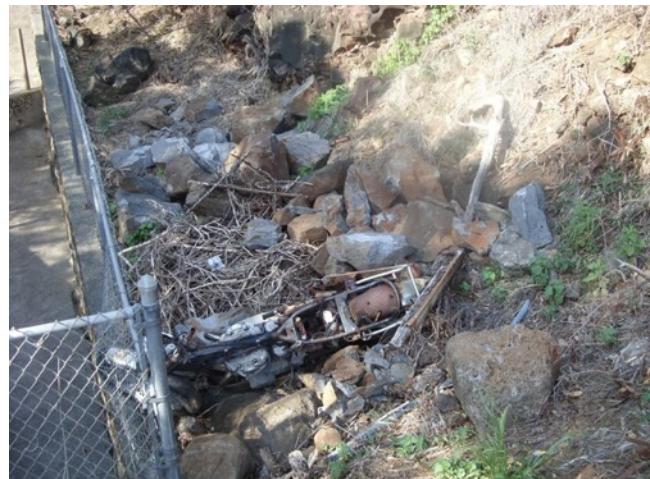
were readily accessible. No pet waste was observed in the park. Illegal dumping or large amounts of trash was observed at one residence (listed as a hotspot) and the catchment basin in Wiliwili Nui Ridge (Figure 9). Yard trash was always bagged.

Figure 9: Illegal dumping at Catchment basin along Wiliwili Nui Ridge. Yard waste and a motorcycle are easily seen in this photograph.

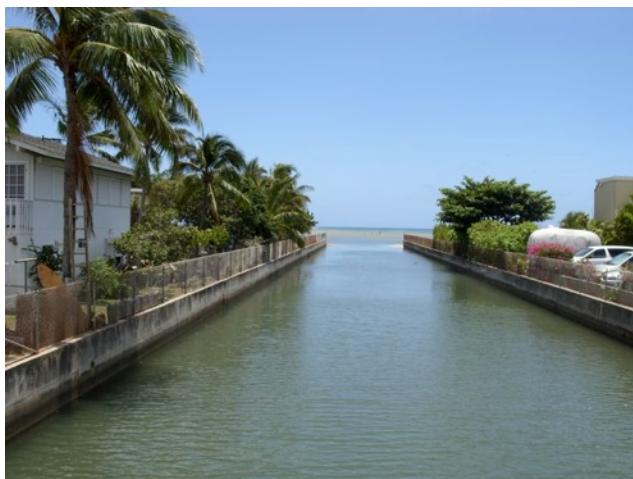
Kuliuou is typical of most streams in the Maunalua area: it has been straightened and lined with concrete in its entirety (Figure 10). This increases the rate at which freshwater flows into Maunalua Bay, with the intent of decreasing flood events to residential areas. However, without a natural sediment bottom and a meandering stream, Freshwater, sediments and pollutants enter the bay at a high rate.

Figure 10: View of Kulioou channel near Kulioou Beach Park. Kulioou is a typical drainage in Maunalua Bay area, as it has been straightened and lined with concrete in its entirety.

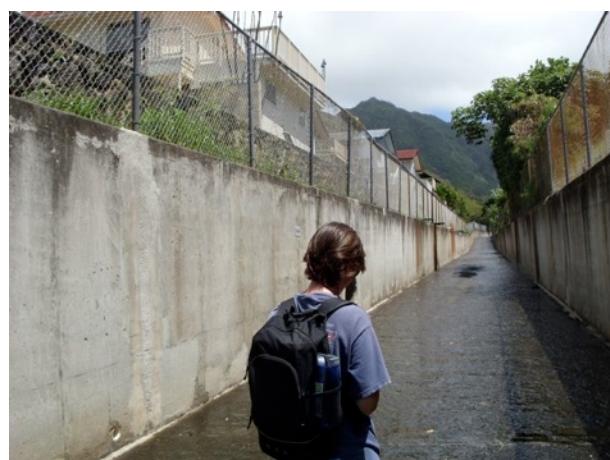
Figure 11: Upper reaches of Kulioou channel, with vertical banks (no quick exit), and pipes from residence connected to channel. Surveys of the upper reaches are not recommended.

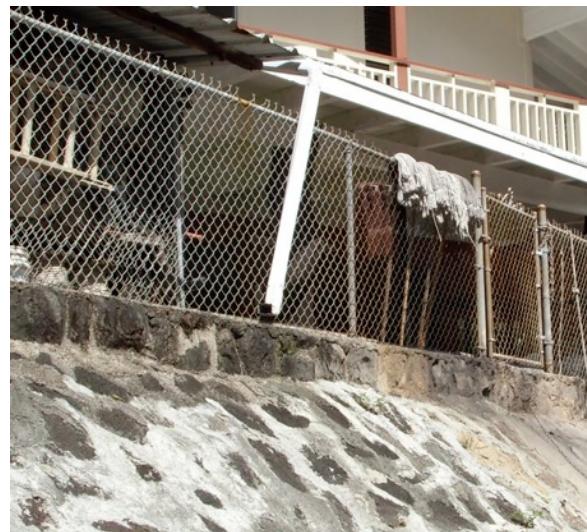
Less than 1% of the houses along Kulioou stream had downspouts directly connected from the roof to the stream channel, although this was observed (Figure 12). At one residence, a garden house was observed running from the house to the stream channel directly. Pipes (corrugated and PVC) running from houses, yards, or walls connected to Kulioou stream was not

Figure 12: Example of rooftop downspout connected to stream channel from residence along Kuliuou channel.

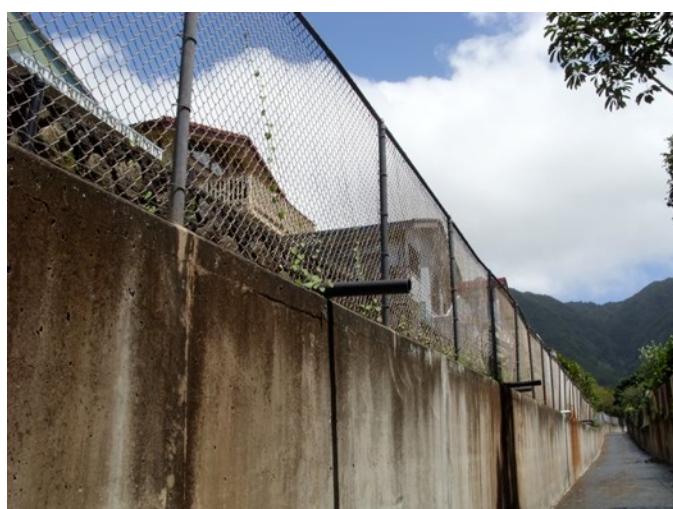
common in the lower reaches of the stream (less than 10% of houses), but increased to close to 100% of houses in the upper channel (reaches 4 and 5; Figure 13). This may be in part due to the steepness of the land increasing as the channel progressed back into the valley, and the density of housing appeared to increase as well. Pipes running from lawns that are fertilized or have pet feces would be a high source of nutrients, pesticides, bacteria, and protozoa.

Figure 13: Almost all houses along Kuliuou channel in the upper reaches have pipes connected to the stream channel. Stains and biofilms are obvious along the bank walls, possibly suggesting high nutrient input or organic matter.

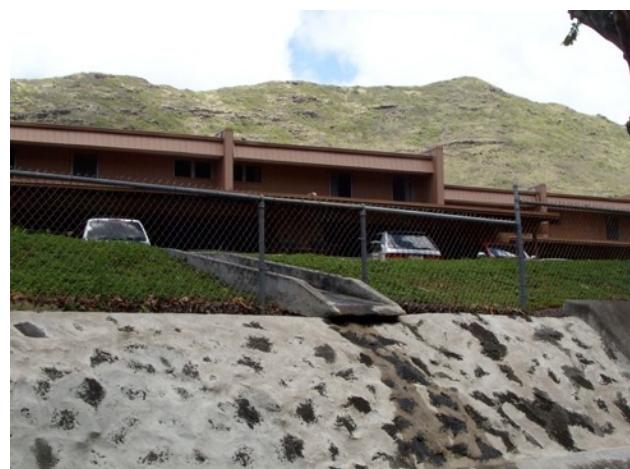
Two residential complexes, Haleloa I and II, had several corrugated pipes running to the stream channel. The parking lots of these complexes have concrete drainage channels connected to Kuliuou channel directly, and are a source of pollutants from cars (Figure 14). These complexes also have highly manicured lawns and would be a source of pesticides and plant material.

Figure 14: Concrete drainage connected to Kulouou channel from parking lot of Haleloa I, a multifamily complex. Decreases filtration of runoff before entering channel and drains a parking lot directly (hotspot).

The multifamily complexes Haleloa I and II were listed as hotspots because 1) the lawns were highly manicured and sources of pesticides (observed people applying them), and 2) the apartments and parking lots had drains connected to Kulioou Channel. Parking lot drains are drained by concrete channels that end at the

channel bank, and pipes are coming from the housing facilities to the stream as well. There is no evidence of storm water treatment, and retrofitting drainages is recommended.

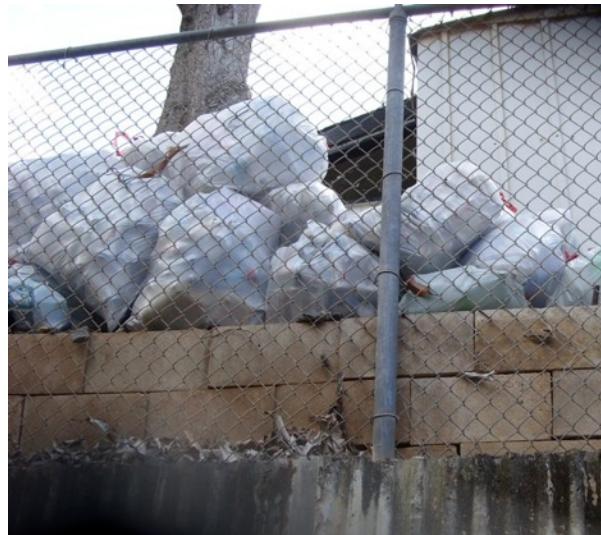
Figure 15: Trash was commonly piled next to Kulioou channel, but at this resident had put trash in bags (many do not have trash in bags).

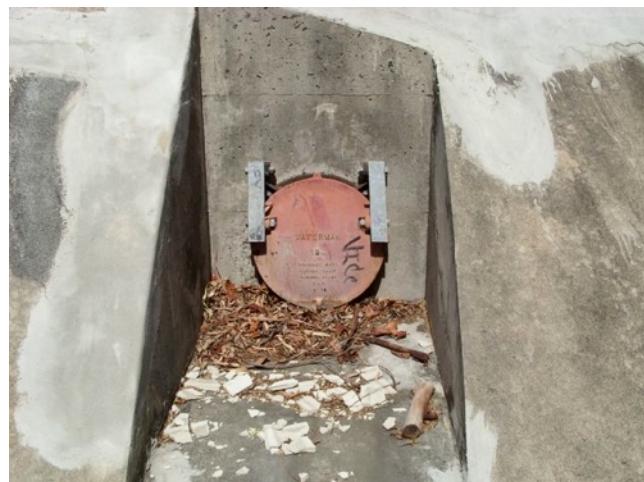
Figure 16: Storm water gate that opens into Kulioou channel. Many were partially blocked by sediments and plant debris.

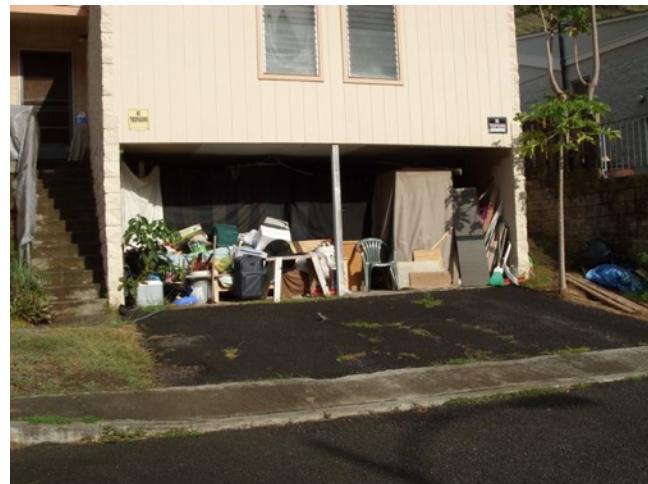
Figure 17: Extremely high storage at a residence in Kulouiu. High storage in carports may lead to leaky chemical containers such as paint and oil, as well as trash accumulating. These can be washed into storm water systems during heavy rains.

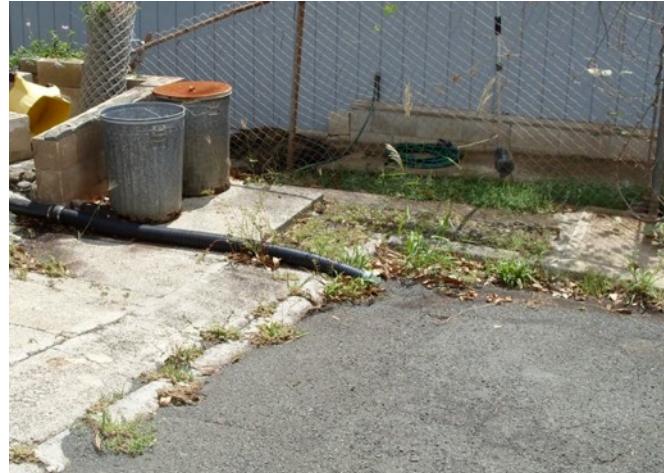
Figure 18: Corrugated pipe running from residence to street, with a storm drain less than 20 feet away from the pipe. It was not clear what the resident was draining.

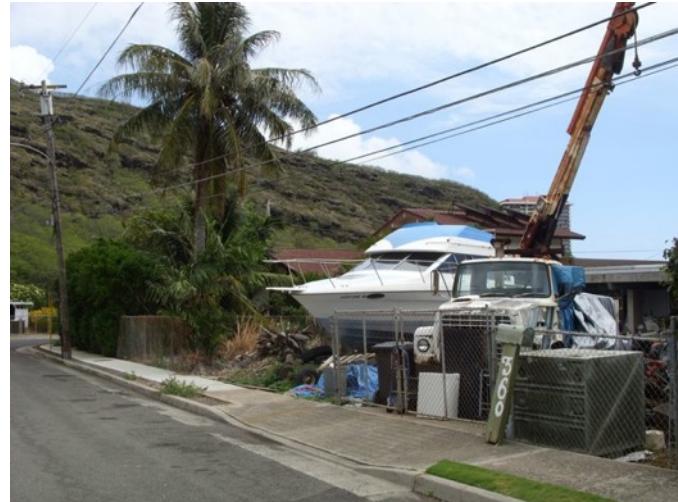
Two lots were classified as hotspots in Kulioou watershed; One was at 360 Dalene, which had rusting vehicles, trees, plant material, roofing material, a crane, a boat, and chemical storage in the yard (Figure 19). At another residence listed as a hotspot, the roof had caved in and roof tiles were in the yard (Figure 20).

Figure 19: Residence characterized as high pollution source with rusting vehicles, chemicals, and lots of plant debris, House appeared abandoned.

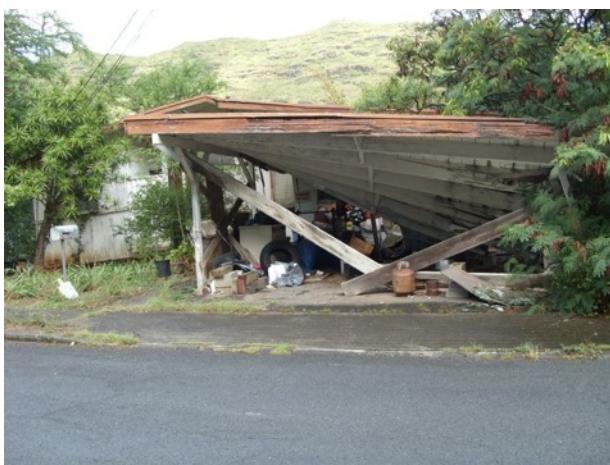
Figure 20: Abandoned home that was listed as a high pollution source due to the amount of waste and
